## Mountain Trails HOA *Phoenix, AZ*

Report #: 46796-0  
Beginning: January 1, 2024  
Expires: December 31, 2024

# RESERVE STUDY "Full"

May 12, 2023

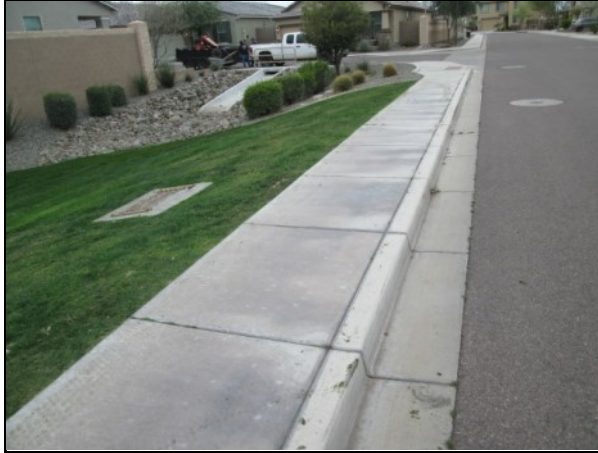
**Comp #: 220 Concrete - Repair****Quantity: Numerous Sq Ft**

Comments: There is no expectancy to completely replace the concrete. No major cracking or trip hazards noted. This component funds an allowance for periodic repairs and partial replacements as needed.

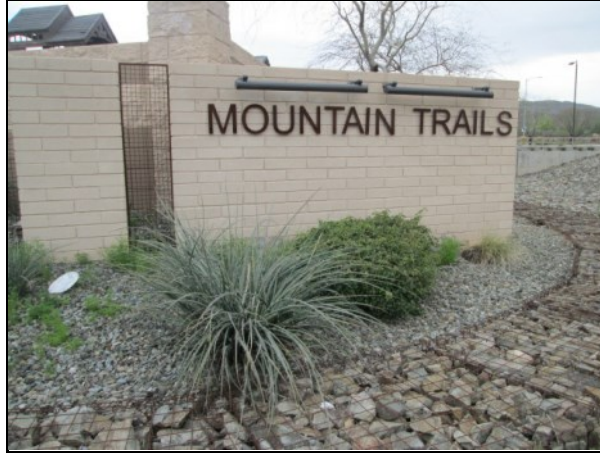
Comments: There is (1) monument with metal letters and (2) lights mounted to a block wall and (1) 1.5' x 2.5' metal sign. Letters read "Mountain Trails." Monuments are still attractive and intact. This component funds an allowance to refurbish/remodel the monuments and replace the lights.

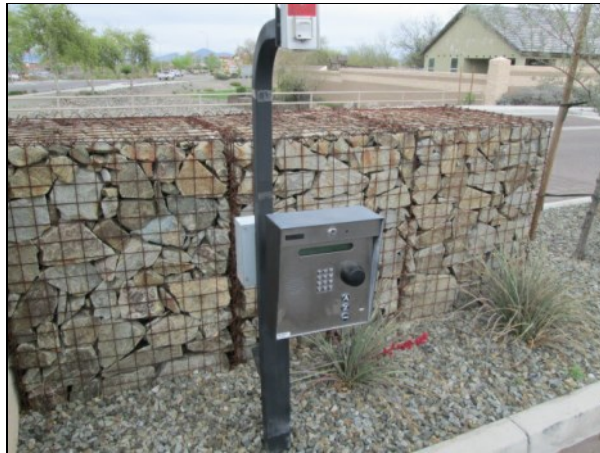
Comments: This component funds replacement of the entry system. It is functional with no physical damage.
